Manhole Inspection Summary

Manhole # S25G__042MH

Insp Date: 1/13/09 11:44 AM

Location Address: **1100 BOOTH ST**

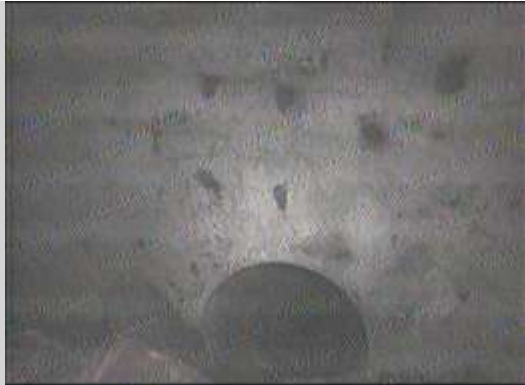
12 O'Clock Outflow

8 in. Circular Gravity Sewer
Pipe Out @ 12 O'Clock

Pipe Height: **8.4** (in.) Rod and Bar (Angled)

Pipe Material: **Clay** ☐ Pipe Lined

Infiltration: **None** Pipe Seal Cond: **Sound**
